Report 1928

**EXPERIMENTAL MODEL,
MARGINAL-TERRAIN ASSAULT BRIDGE AND ARMORED
PERSONNEL CARRIER TRANSPORTER AND LAUNCHER**

**U. S. ARMY MOBILITY EQUIPMENT RESEARCH AND DEVELOPMENT CENTER
FORT BELVOIR, VIRGINIA**

This report presents information on an experimental model of a lightweight, short-span, marginal-terrain assault bridge and transporting launcher. The model tested is a 33-foot bridge span transported and launched by an M-113 Armored Personnel Carrier.

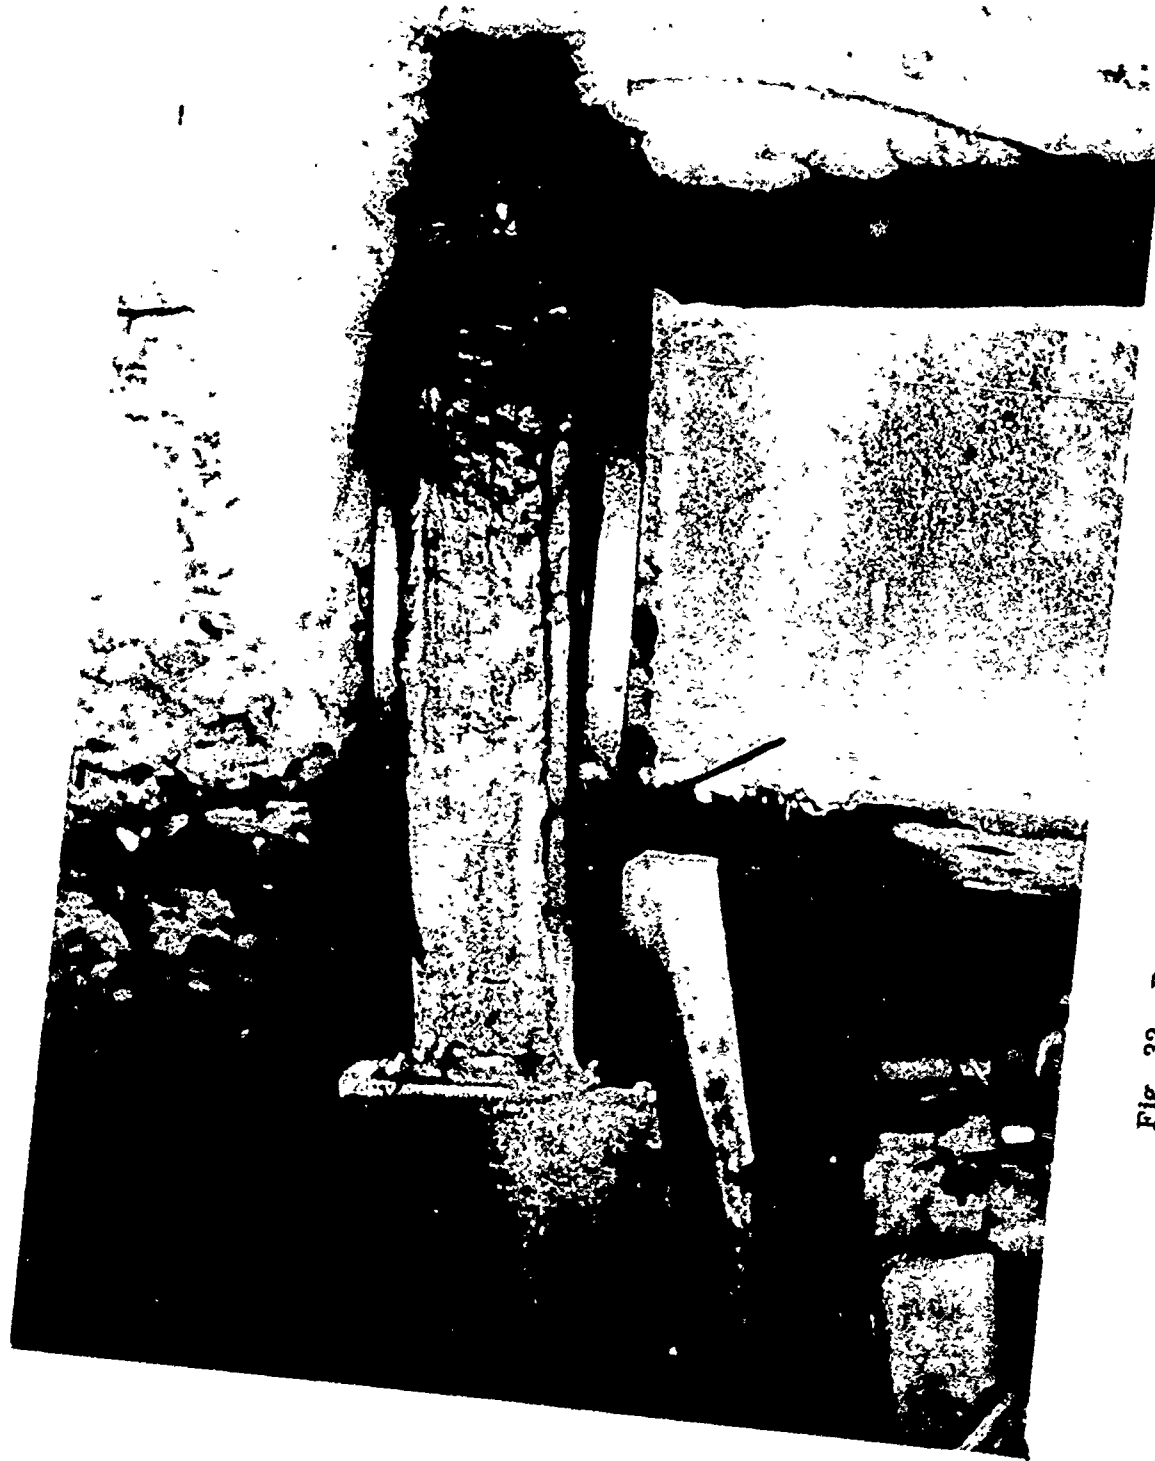
P5778

The failure caused racking of the mechanism (Fig. 31) and bent the end plate and trunnion mount on the left end of the tongue-frame crossbeam (Fig. 32). The racking action gave a permanent set in torsion to the rotating link. The link was cold straightened by a press, and the end plate and trunnion were cold straightened by driving. The crushed end of the launching beam was replaced with 1/2-inch web plates; the unfailed, left-side, launching-beam webs were stiffened with 1/4-inch plates. This arrangement still required the use of 1/2-inch-thick bearing plates to be welded on at the pinhole. For cost reduction and ease of fabrication, the web plates on a production model would be 1 inch thick (Fig. 30). The 1/2 inch webs were strain gaged during subsequent testing (Gage No. 48, Table X).

Fig. 32. Bending of crossbeam end plate and trunnion pin.

After 945 cycles, the left end plate of the crossbeam sheared (see arrow, Fig. 32). No other damage was sustained, and the plate was rewelded with a larger weld. The right end plate was also rewelded as insurance against a similar failure. No other action was taken since the failure was precipitated by bending caused during the launching-beam failure and subsequent straightening during repair.

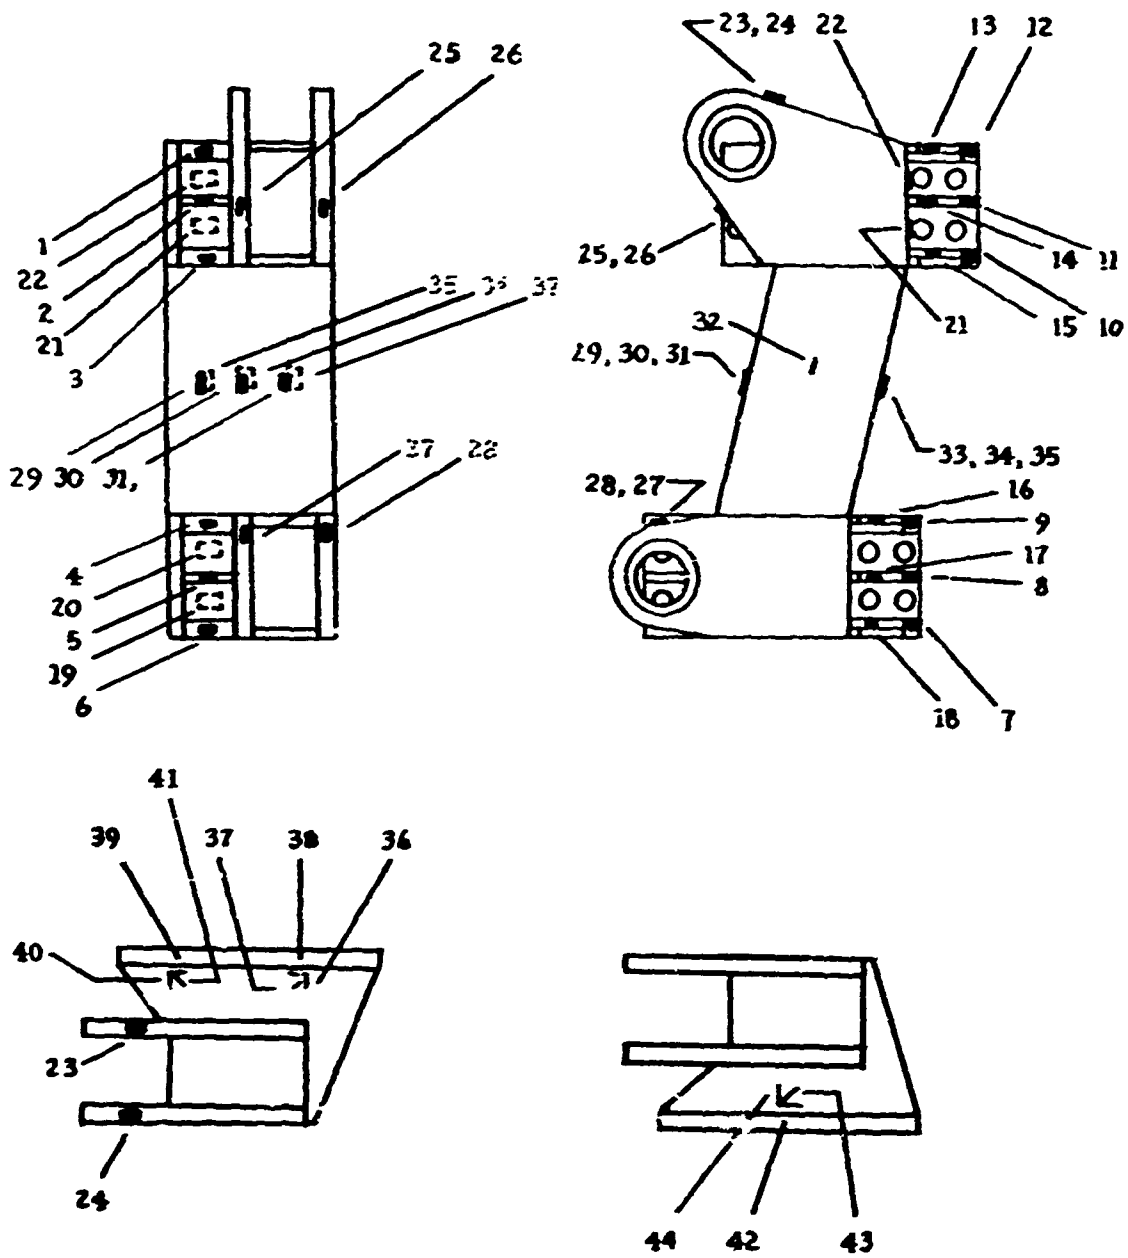
Fig. 35. Strain gage locations.

Dynamic stress recordings were made for the same non-shock, shock, and sideslope shock conditions as before; results of these tests appear in Table X (Strain gage locations are shown in Fig. 35). A rosette placed on the welded mount was gage numbers 45, 46, and 47. The rosette was located on the bottom of the lower mount adjacent to the connecting weld and approximately 3 inches behind the forward edge. Gage number 48 was placed on the centerline of the launching beam in front of the mount pin. This was the area that previously failed under compression. The recorded stresses for the 1/2-inch webs gave no further insight to failure in the 1/4-inch webs.

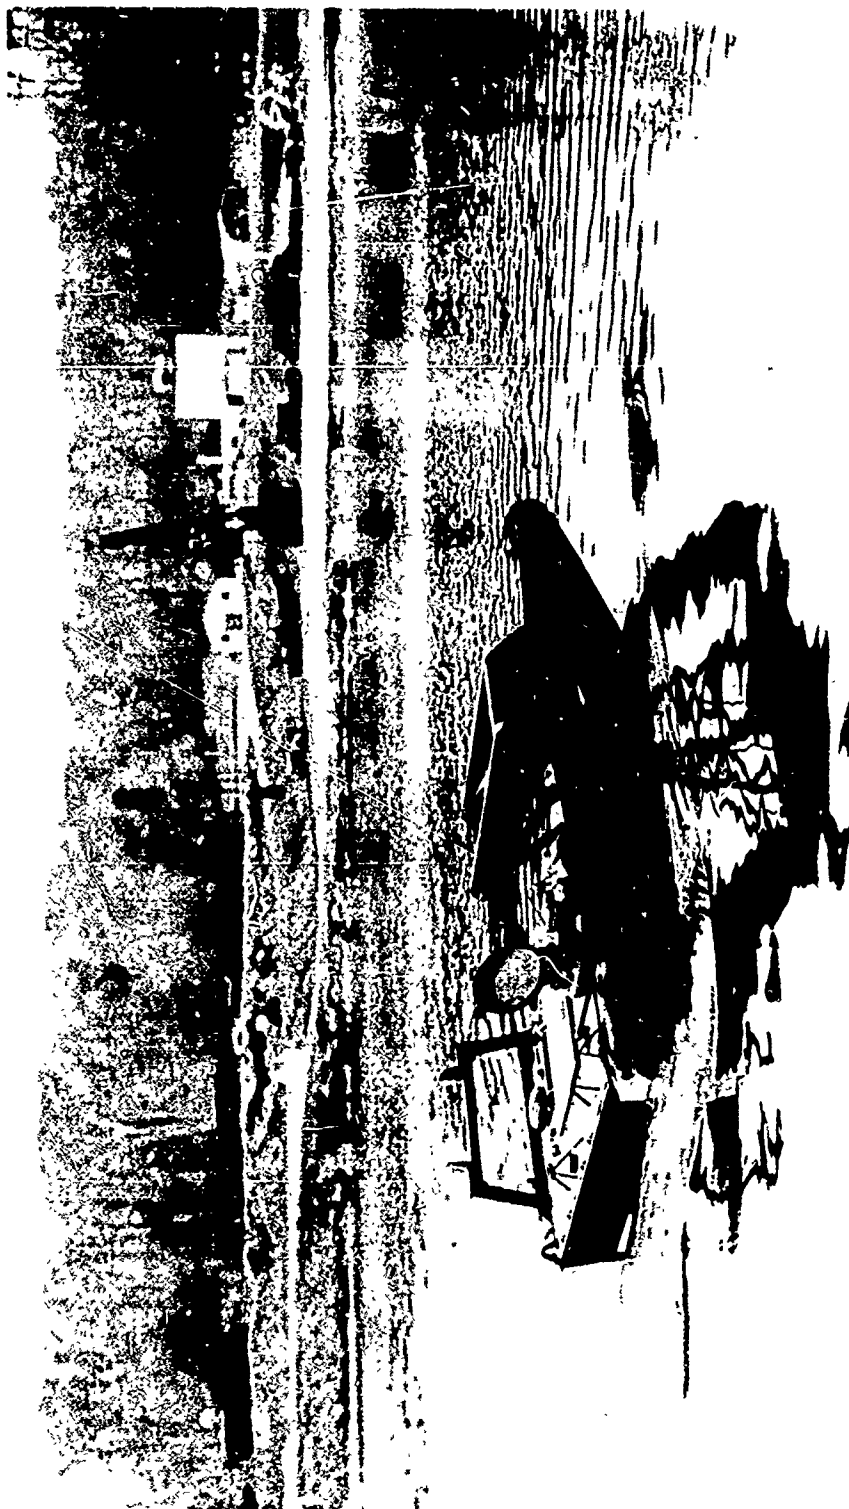
P11448

Fig. 36. The M-113A1 launcher, without bridge, at full speed.
